BUTRINT 6

EXCAVATIONS ON THE VRINA PLAIN

Volume 1

THE LOST ROMAN AND BYZANTINE SUBURB

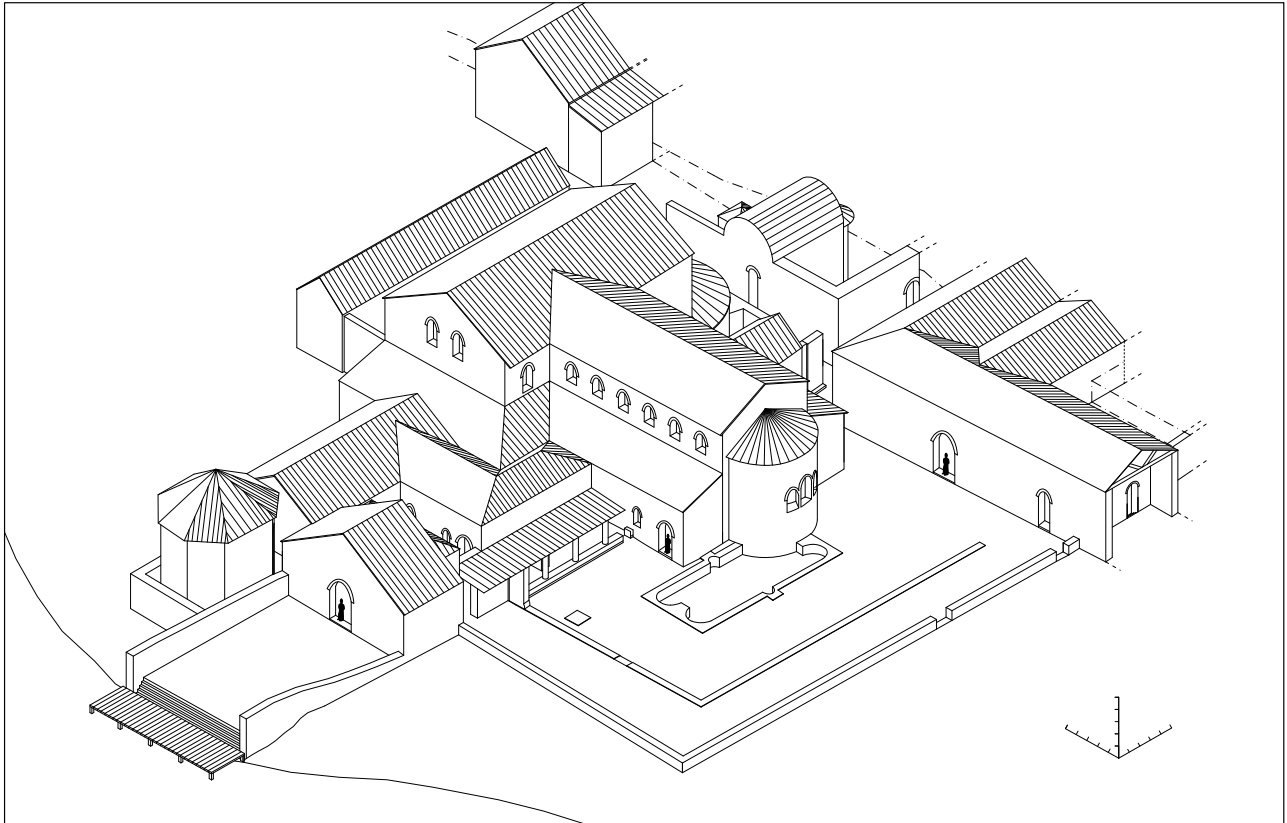
Figure 6.99. Hypothetical reconstruction of the basilica and surrounding rooms in Phase 7

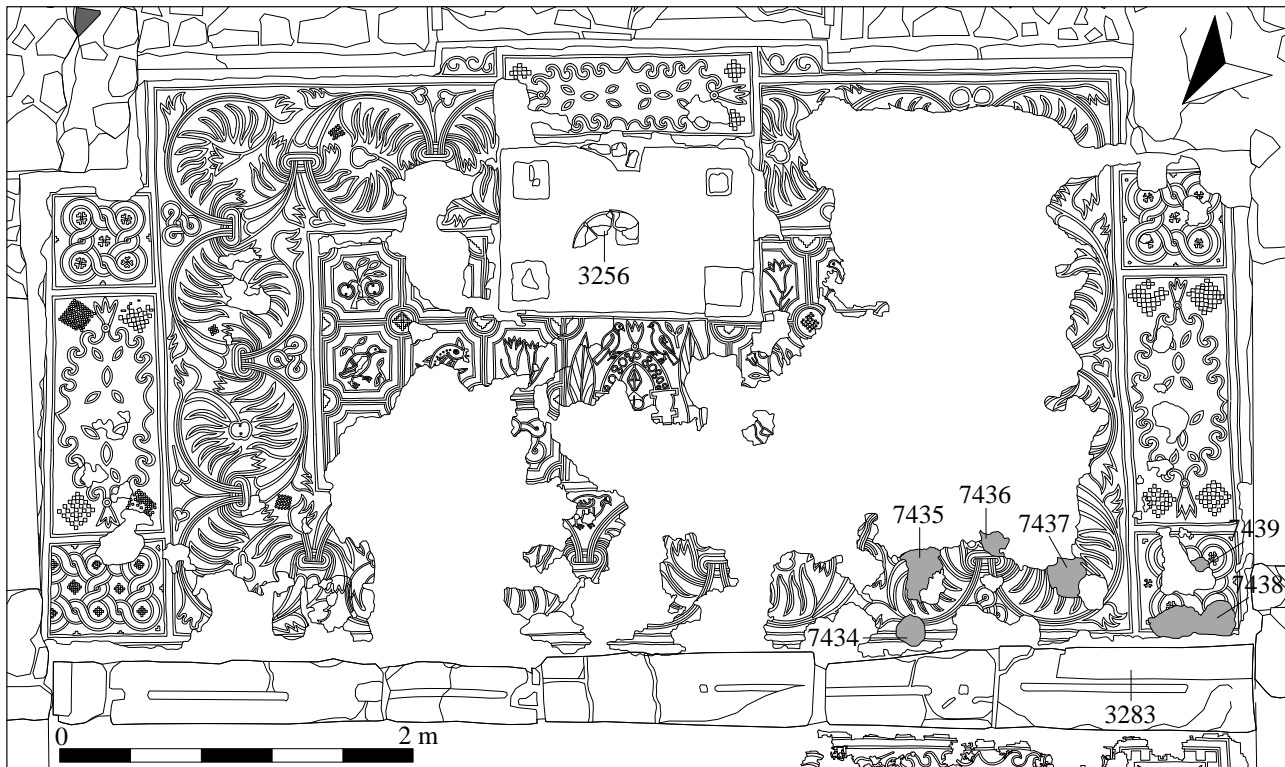
Figure 7.20. Plan showing the position of the Phase 11 temporary posts used to support the sanctuary roof

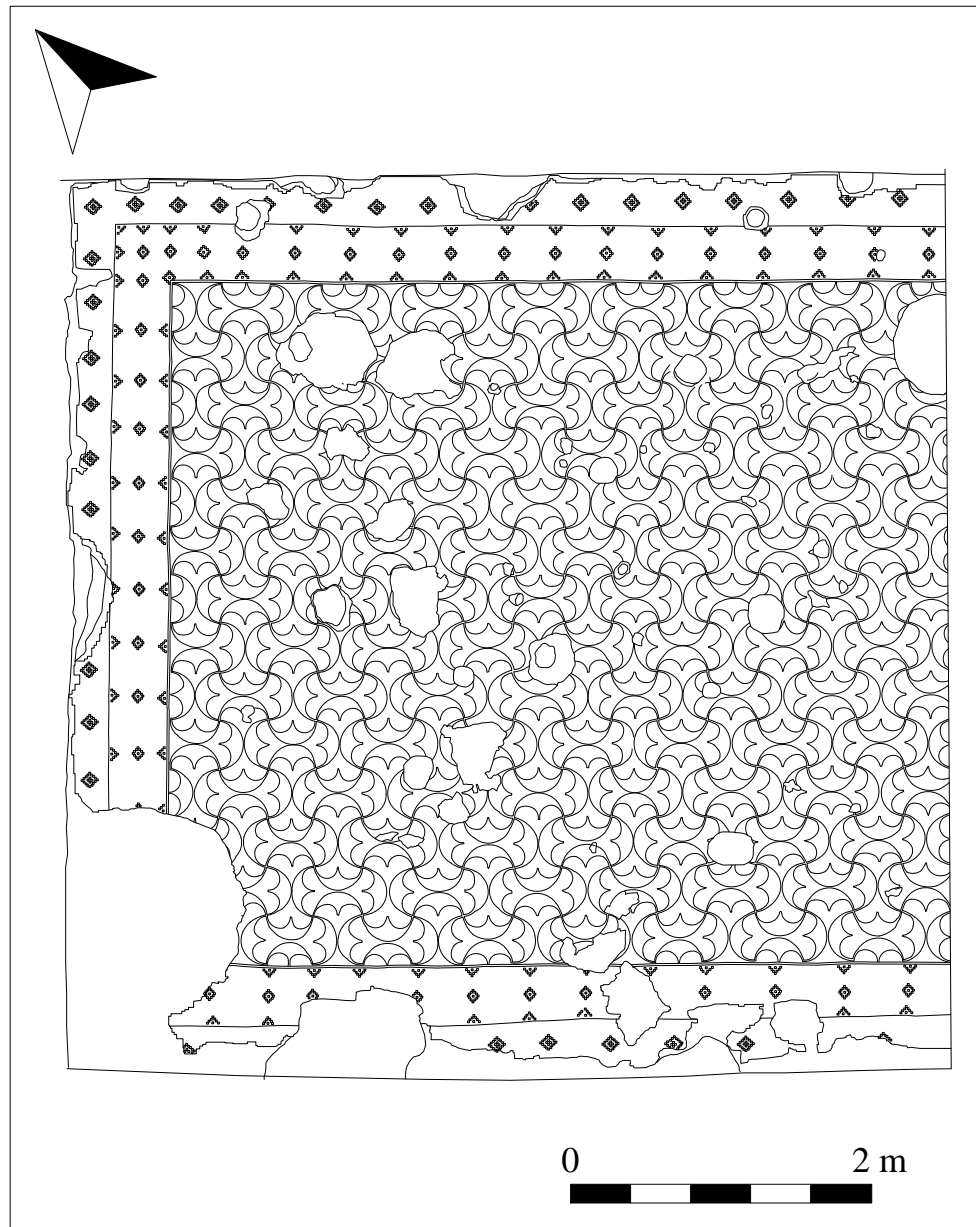
Figure 10.4. Plan of the mosaic pavement in Room 3 (Mosaic 3499)
